**State of Louisiana
Department of Natural Resources
Coastal Engineering Division**

**2005/2006 Annual Inspection
Report**

**SABINE REFUGE STRUCTURE
REPLACEMENT PROJECT
(CS-23)**

October 13, 2005
Cameron Parish

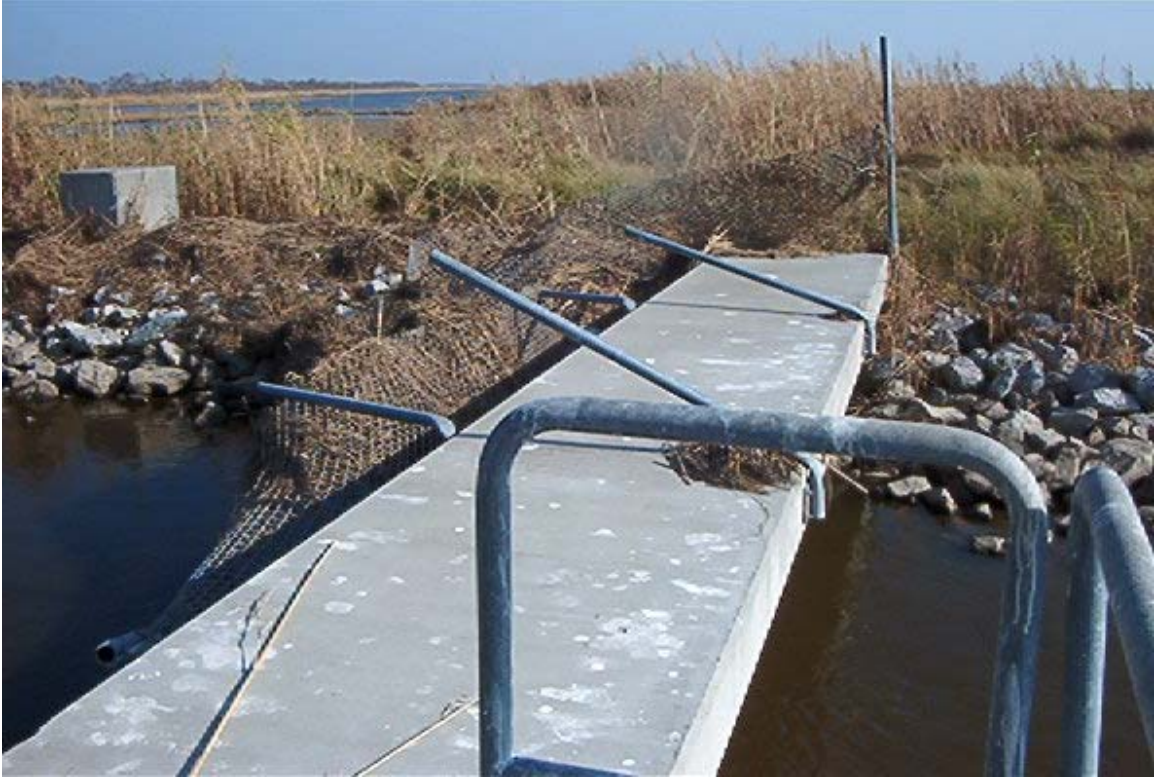
The chain link security fence was demolished on both the north and south sides of the structure. The posts were bent and can be unbolted from the structure and new posts installed. The mesh has to be replaced.

The aluminum brace bolted between the gate guides and the concrete structure was bent, which indicates the gates were twisted. The braces should be replaced and stems realigned with the gate and operating nut. This may require that the pedestal flanges be machined to make sure that the two flanges are parallel. (Photos: Appendix B, Photos 1 - 2)

Photo 1, North Walkway On Hog Island Gully Structure

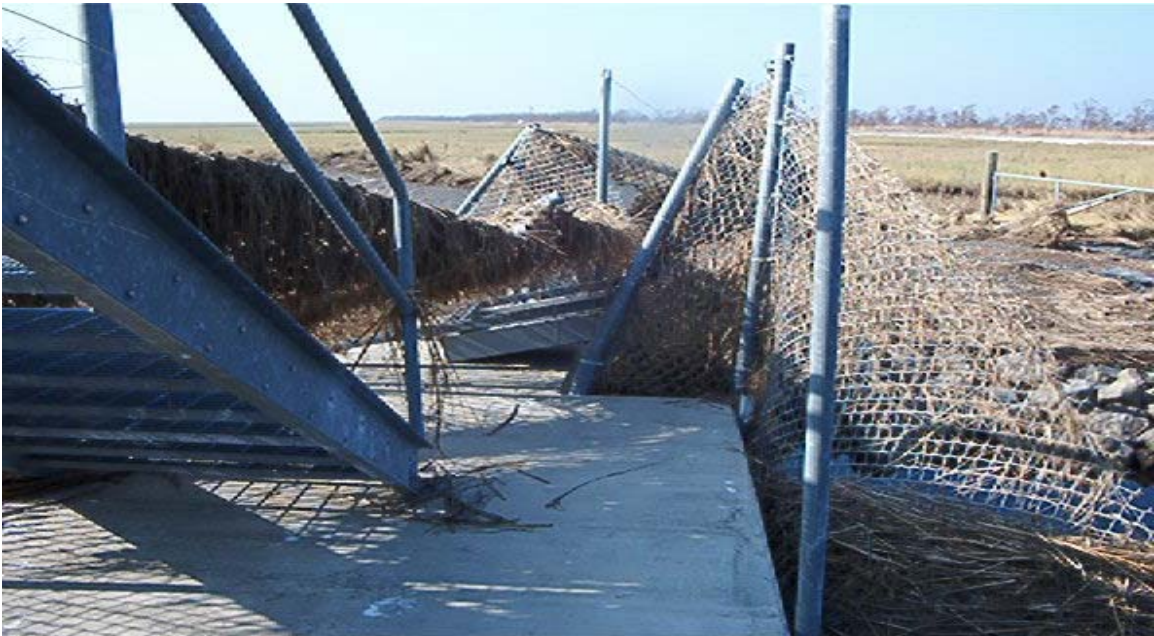
Photo 2, South Walkway On Hog Island Gully Structure

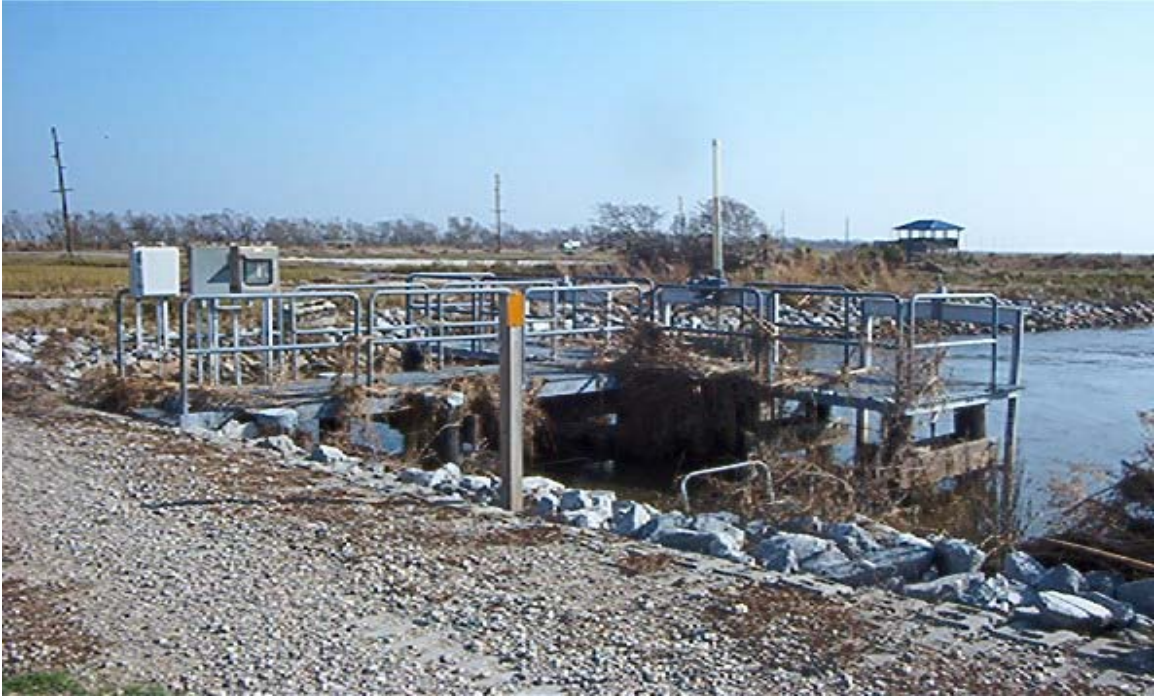
This structure was completely submerged. The electrical power panel had grass debris and water inside. It will have to be changed and should be installed at a higher elevation. The cover on the electronic actuator controller was removed and there was an indication of moisture inside. The actuator will have to be dismantled to determine if it can be salvaged. Walkways, platforms and structures were all in good condition. (Photos: Appendix B, Photos 3-4).

Photo 3, Headquarters' Canal Structure

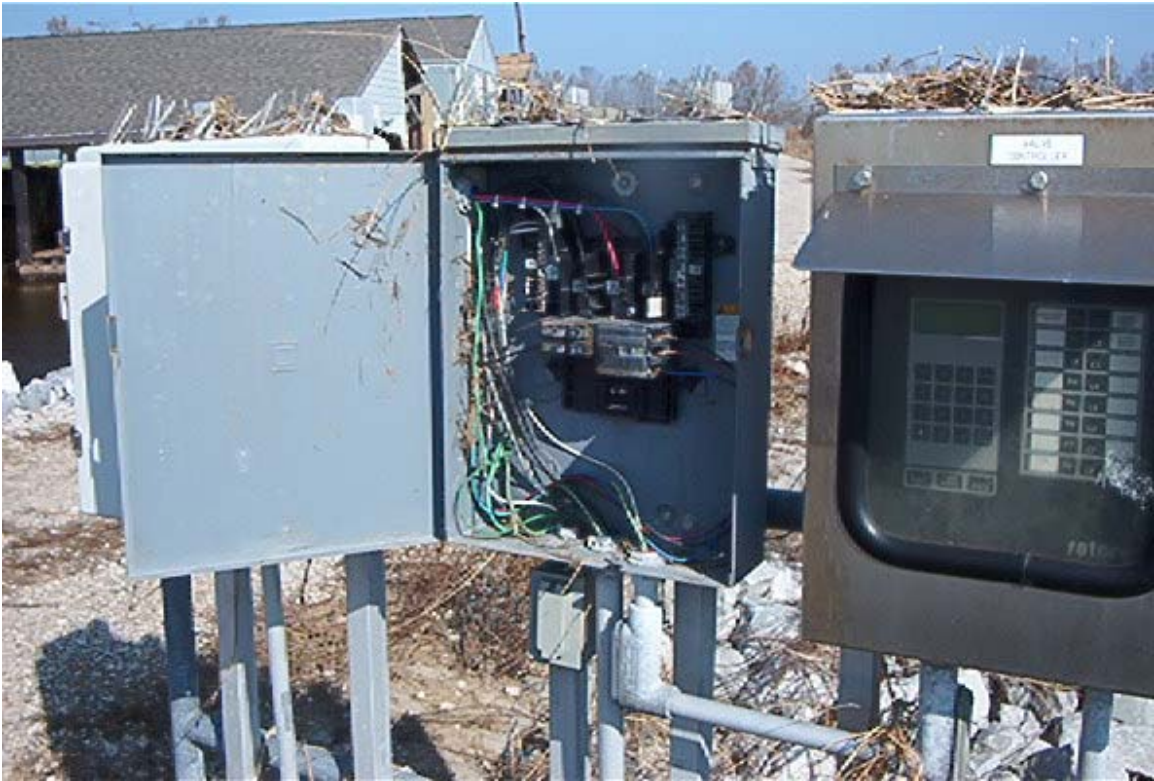
Photo 4, Grass and Water Inside Panel Box Headquarters' Canal Structure

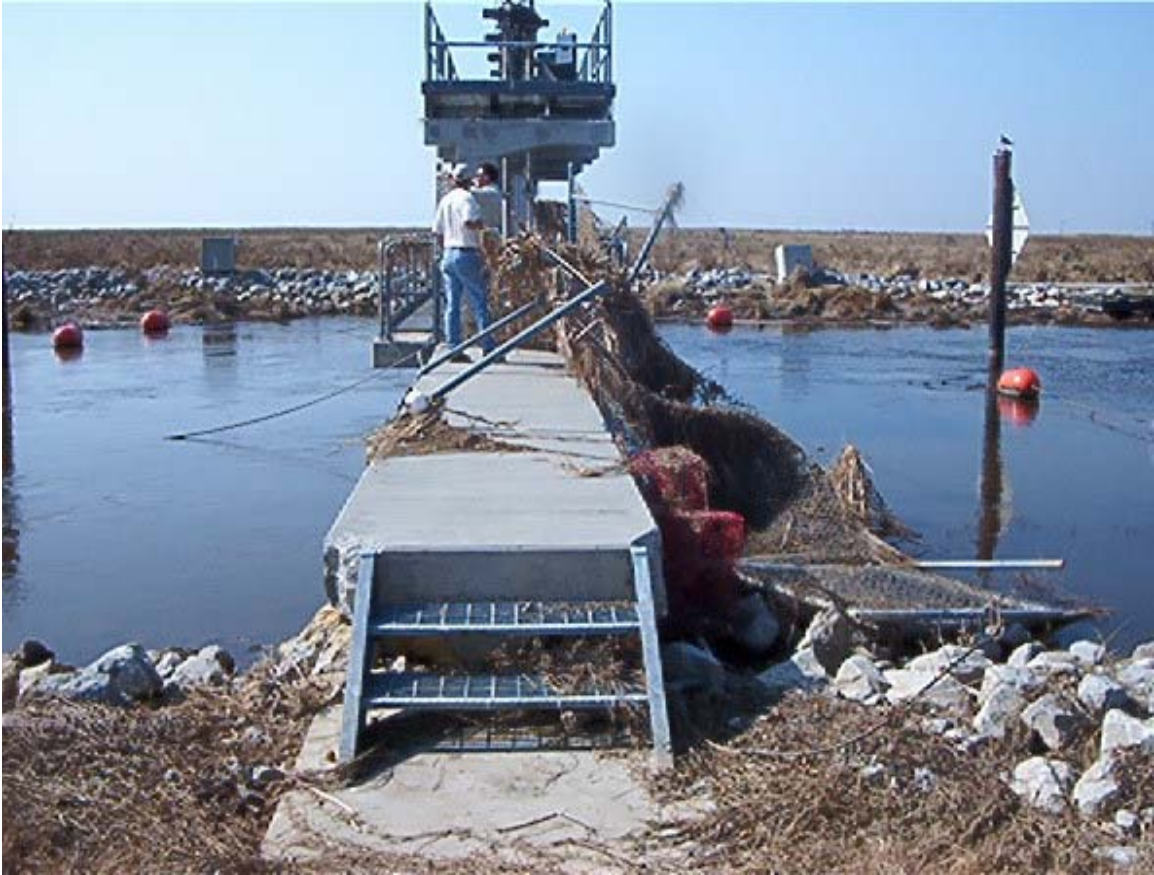
The chain link security fence was demolished on both the north and south sides of the structure. The posts were bent and can be unbolted from the structure and new posts installed. The mesh has to be replaced.

Photo 5, North Walkway On West Cove Canal Structure

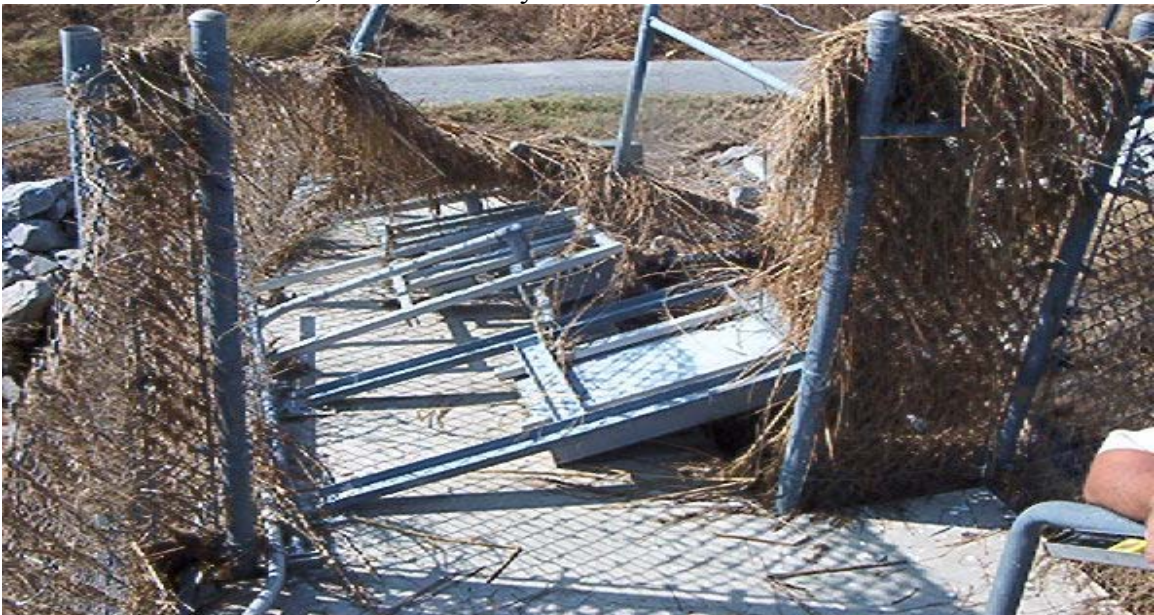
Photo 6, South Walkway On West Cove Canal Structure

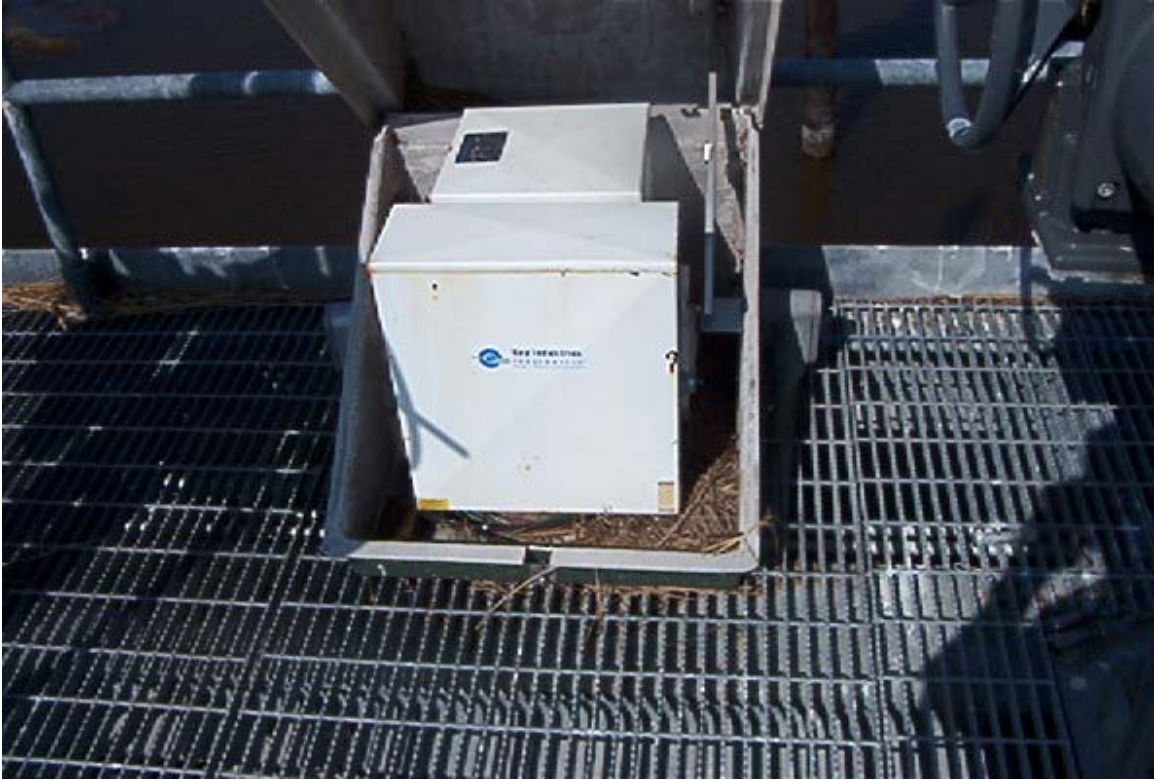
The electrical power panels were completely submerged and will have to be changed. These panels should be relocated to the top of the platform. The variable frequency drive enclosure had grass debris inside of it indicating it had been under water, so it will have to be replaced. A cover on an electronic actuator controller was removed and there was an indication of moisture inside. The bottom drain plug was removed and a considerable quantity of water drained out. All of the actuators will have to be taken apart and determined if they can be salvaged.

Photo 7, Grass And Debris Inside Variable Frequency Drive Enclosure West Cove Canal Structure

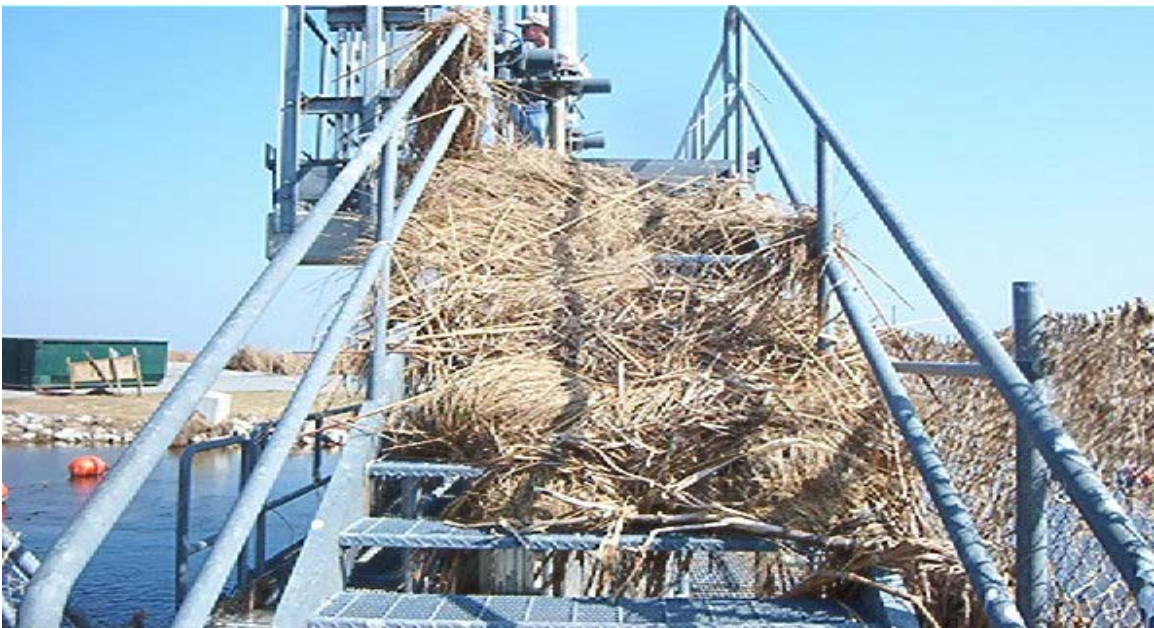
Alignment of the stem with the gate and operating nut should be checked. Realignment may require that the pedestal flanges be machined to make sure that the two are parallel. There is no damage to the fishing piers or boat launches. (Photos: Appendix B, Photos 5-8).

Photo 8, Storm Surge Topped The Top Platform At West Cove Canal Structure
